Medical Devices: The Therac-25*

Nancy Leveson
University of Washington

Between June 1985 and January 1987, a computer-controlled radiation therapy machine, called the Therac-25, massively overdosed six people. These accidents have been described as the worst in the 35-year history of medical accelerators [6].

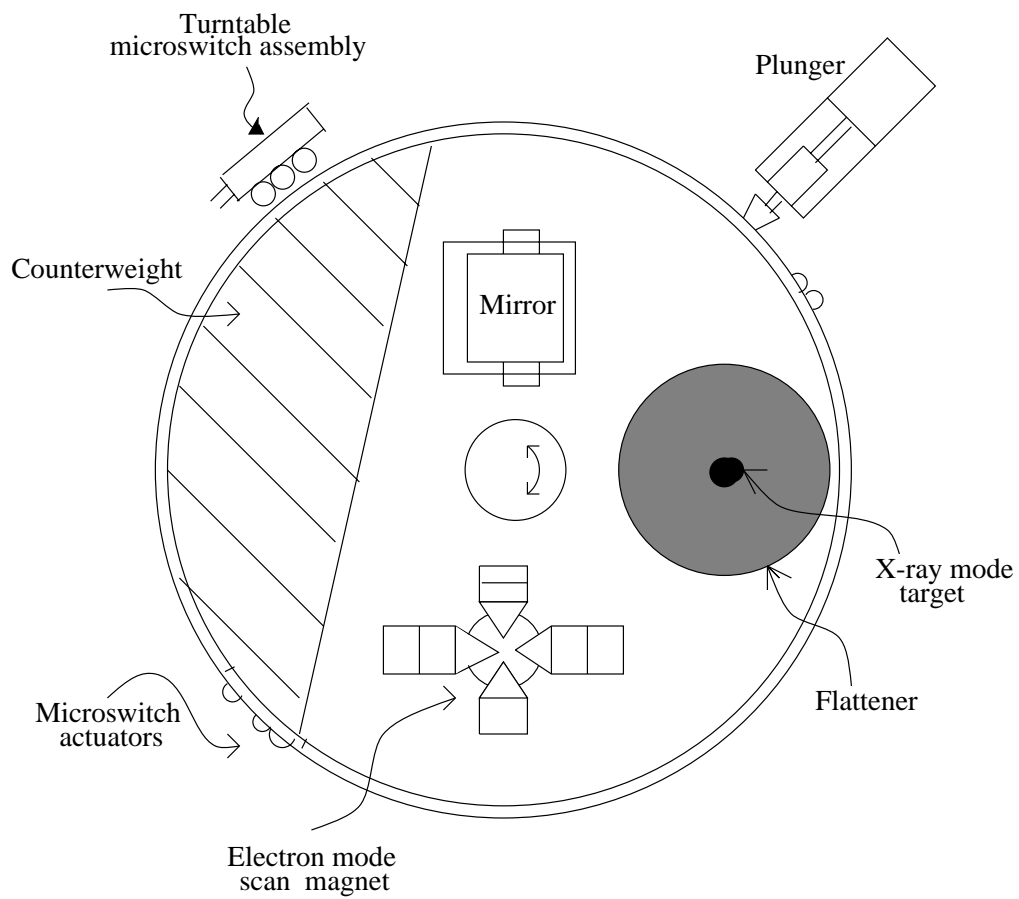
Figure 1: Upper turntable assembly.

Turntable Positioning. The Therac-25 turntable design plays an important role in the accidents. The upper turntable (see Figure 1) rotates accessory equipment into the beam path to produce two therapeutic modes: electron mode and photon mode. A third position (called the field light position) involves no beam at all, but rather is used to facilitate correct positioning of the patient. Because the accessories appropriate to each mode

are physically attached to the turntable, proper operation of the Therac-25 is heavily dependent on the turntable position, which is monitored by three microswitches.

The computer senses and controls turntable position by reading a 3-bit signal about the status of three microswitches in the turntable switch assembly. Essentially, AECL determined that a 1-bit error in the microswitch codes (which could be caused by a single open-circuit fault on the switch lines) could produce an ambiguous position message to the computer. The problem was exacerbated by the design of the mechanism that extends a plunger to lock the turntable when it is in one of the three cardinal positions: The plunger could be extended when the turntable was way out of position, thus giving a second false position indication. AECL devised a method to indicate turntable position that tolerated a 1-bit error so that the code would still unambiguously reveal correct position with any one microswitch failure.

The modifications specified in the Symonds report included redesigning the microswitch and changing the way the computer handled malfunction conditions. In particular, treatment was to be terminated in the event of a dose-rate malfunction, giving a treatment “suspend.” This change would have removed the option to proceed simply by pressing the \textcircled{P} key. The report also made recommendations regarding collimator test procedures and message and command formats. A November 8, 1985 letter, signed by the director of the Canadian RPB, asked that AECL make changes to the Therac-25 based on the Symond’s report “to be in compliance with the RED act.”

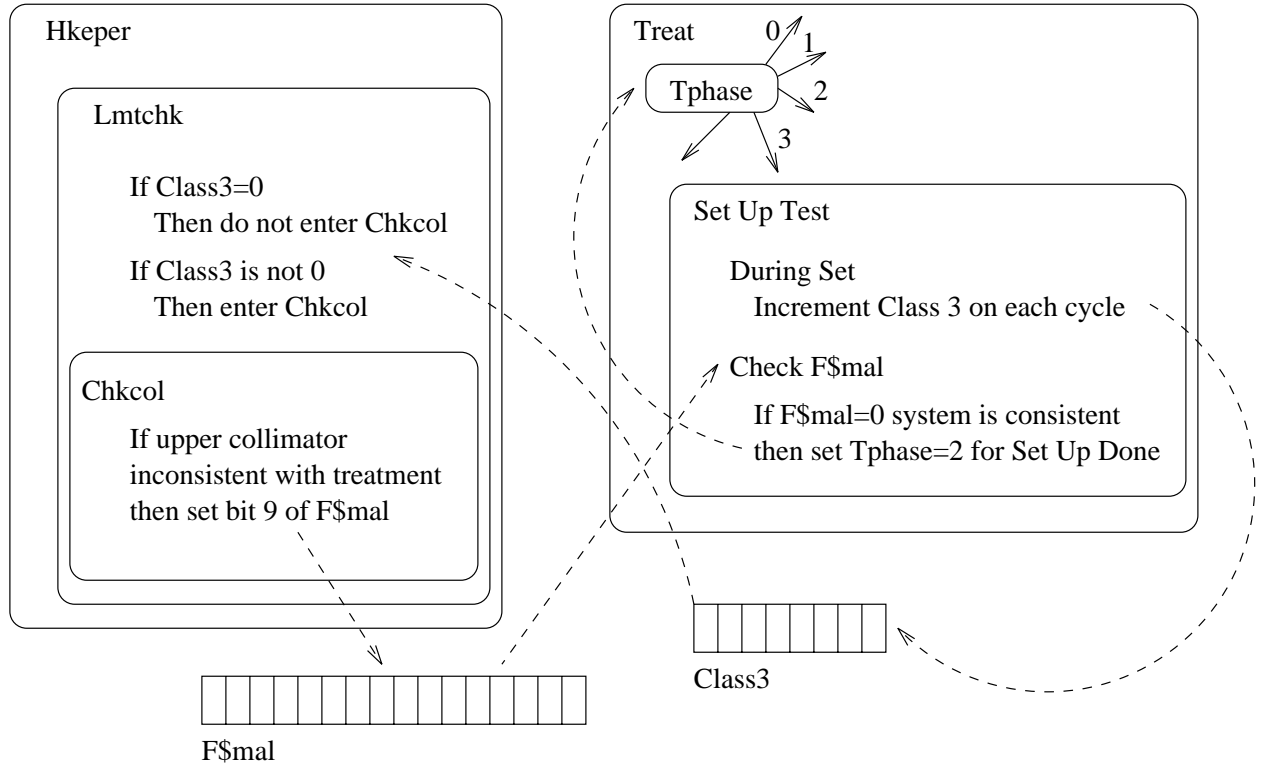
Figure 4: The Yakima software flaw.

The second Yakima accident was again attributed to a type of race condition in the software — this one allowed the device to be activated in an error setting (a “failure” of a software interlock). The Tyler accidents were related to problems in the data-entry routines that allowed the code to proceed to Set Up Test before the full prescription had been entered and acted upon. The Yakima accident involved problems encountered later in the logic after the treatment monitor Treat reaches Set Up Test.

Normally, the operator enters all the prescription data at the console (outside the treatment room) before the final setup of all machine parameters is completed in the treatment room. This gives rise to an UNVERIFIED condition at the console. The operator then completes patient setup in the treatment room, and all relevant parameters now VERIFY. The console displays a message to PRESS SET BUTTON while the turntable is in the field light position. The operator now presses the *set* button on the hand control or types “set” at the console. That should set the collimator to the proper position for treatment.

The overexposure occurred when the operator hit the “set” button at the precise moment that Class3 rolled over to zero. Thus, Chkcol was not executed and F\$mal was not set to indicate that the upper collimator was still in the field-light position. The software turned on the full 25 MeV without the target in place and without scanning. A highly concentrated electron beam resulted, which was scattered and deflected by the stainless
